Report of main engine damage on xxxxxxxxxxxxxxxxxxxx

Main Engine is MAN B&W, type 9L32/40, ser No. xxxxxxxx 750 rpm, 4320 kW, built 2002, on board newbuilt Ship from xxxx.

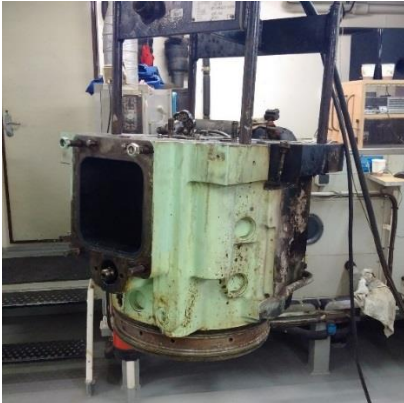
Cylinder cover dismantled from Cylinder No7, has been found damaged in following areas: part of compression chamber, all 4 valves (2 air intake valves and 2 exhaust gas outlet valves) and one exhaust gas valve guide (liner). Compression chamber is damaged by metal pieces found between piston crown and cylinder cover when engine was running and metal piece was pushed by piston to cylinder cover. That metal piece (later will be explained what piece is that) was of greater dimension (thickness) than compression chamber height (when piston reaches TDC). Piece bigger than compression chamber height pressed between piston and cylinder cover, caused surface deterioration of cylinder cover and piston crown, as it could be seen on Photos below. Main engine operates with 750 rpm, so it is to conclude that metal piece has been “forged” by piston and cylinder cover. Cylinder cover was anvil part of “forging” process.

Damaged cylinder cover, charging air side

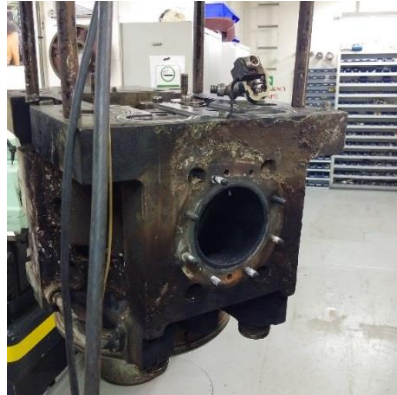
Damaged cylinder cover, exhaust gas side

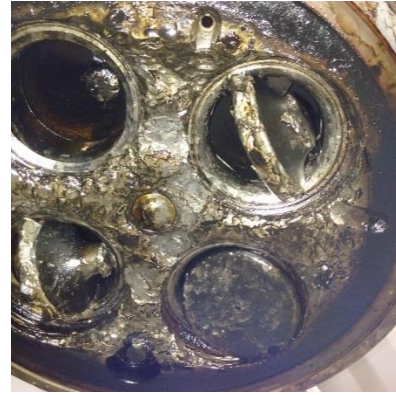
Valve crowns broken and rotated

Exhaust forward valve has been found with valve crown missing, stem buckled, with fin part still on valve's stem.
 Exhaust rear valve has been found with valve crown broken, rotated for 90° from original stem vertical position and pressed in valve seat; also with stem buckled and fin part separated from the stem.
 Inlet forward valve has been found with broken valve crown, rotated for 90° from original stem vertical position and pressed in valve seat.
 Inlet rear valve has been found not broken, just with buckled stem and punched valve crown bottom.
 To conclude, only 1 valve (fresh air inlet rear valve, has been found with valve crown still connected with valve's stem.
 Other 3 valves have their crown detached from valve's stem.
 Valve opening pushers have been found slightly deformed (about 1,5 mm bended) on lower part (bigger diameter).

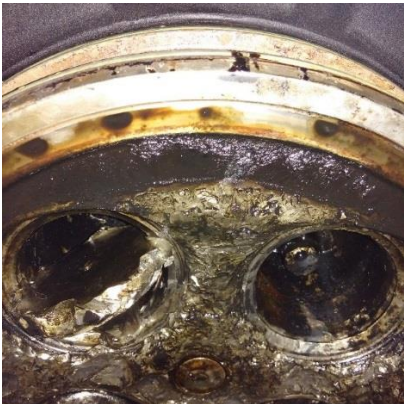
Cylinder cover valve seats

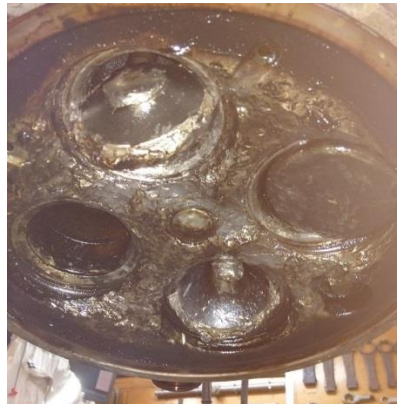
Cylinder cover bottom side

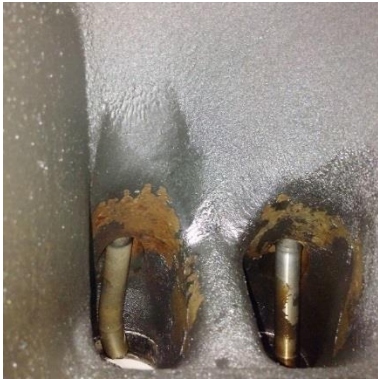
Damaged valves stems, air intake side

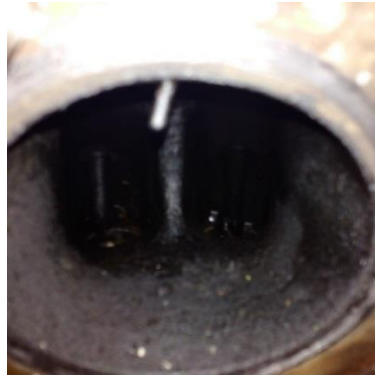
Damaged valves stems, exhaust gas side

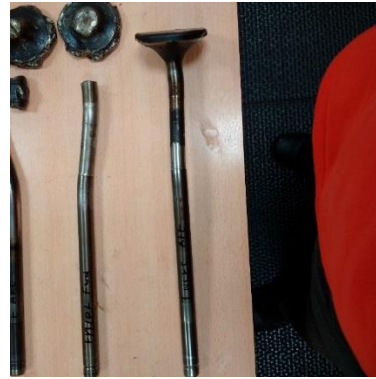
Damaged air inlet valves

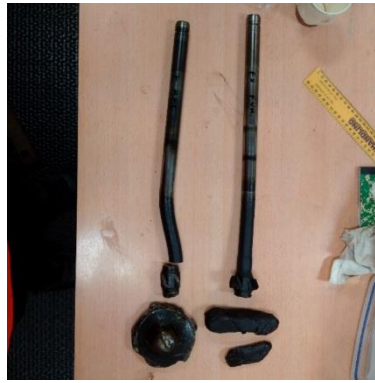
Damaged exhaust gas valves

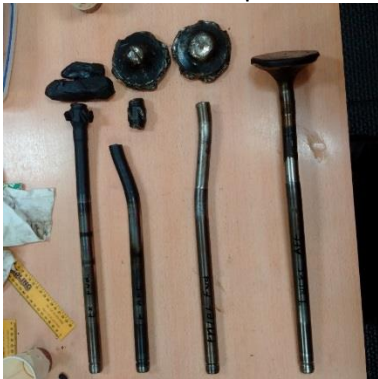
All 4 damaged valves

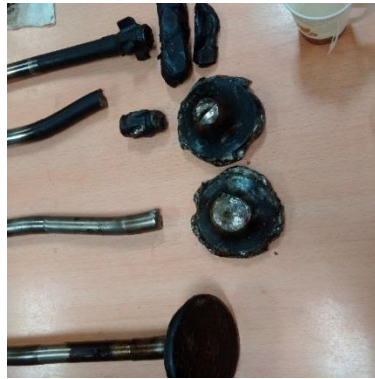
Valves crowns

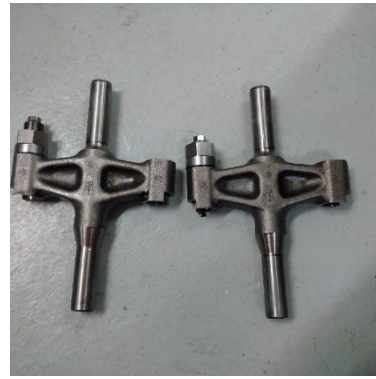
Valves opening pushers, slightly deformed

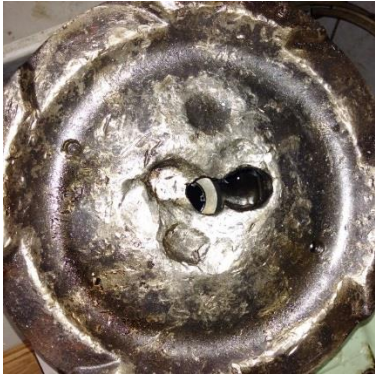
Piston crown was another (hammer) part of “forging” process inside cylinder No. 7. Piston crown has been found broken in the middle because wall thickness is the smallest. On outer diameter similar surface deteriorations are noted as on cylinder cover. It is clear that metal part when was pressed between piston and cylinder cover, squeezed out some parts of piston crown surface, same as on cylinder cover.

Damaged piston, top view

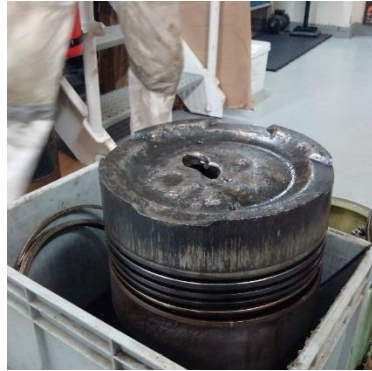
Damaged piston, side view

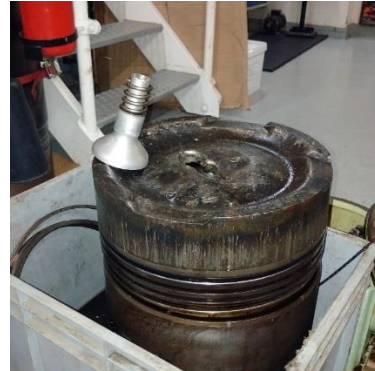
Damaged piston with broken piece of connecting rod

Connecting rod has been found damaged on it's top part above piston pin axe. Top part of the Rod is broken and detached from connecting rod. (*Broken part is visible at the top of damaged piston, on the most right Photo in Piston section*).

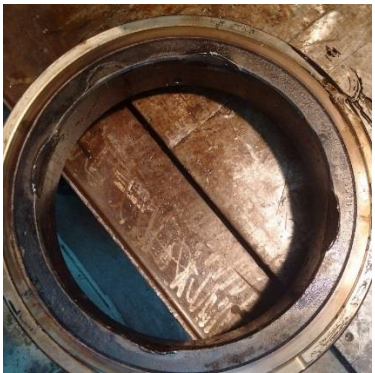
Topland ring (ring between cylinder cover and cylinder liner) has been found damaged on inner edges. It is clear ring's material is also squeezed out on several positions around ring.

Damaged topland ring, top view

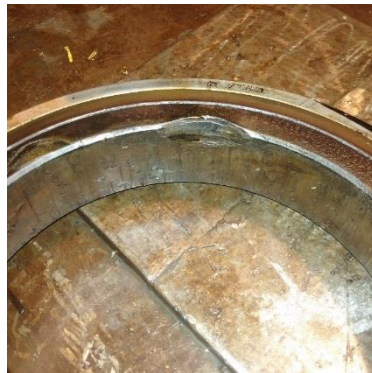
Damaged topland ring

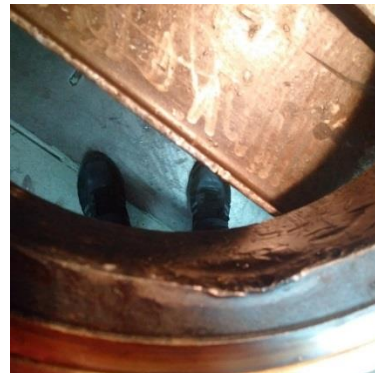
Local damage on topland ring

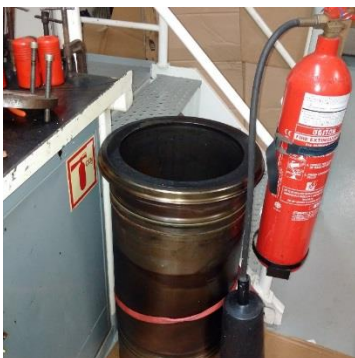
Cylinder liner has vertical scratches. Scratches are randomly placed around liner. Depth of scratches is less than 1 mm. Those scratches occurred when small detached metal parts were placed between moving piston rings and stationary cylinder liner.

Damaged cylinder liner

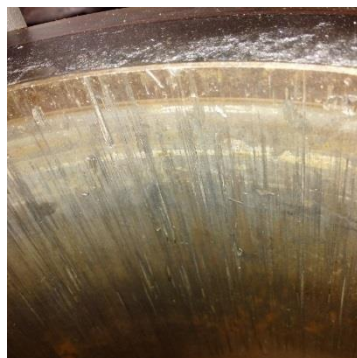
Scratches on cylinder liner

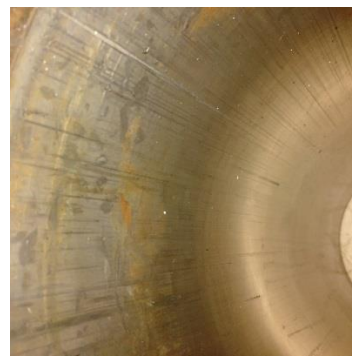
More scratches on cylinder liner

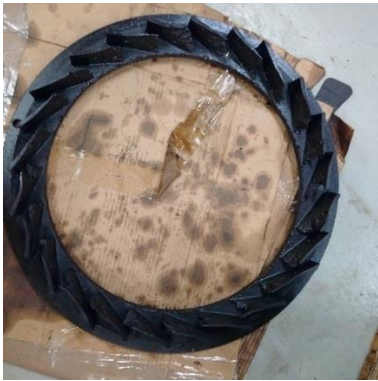
One type are erosion cavities on the fins, which are most likely result of use, not related to this damage. As exhaust gases pass through nozzle blades, sometimes with turbulent streaming flow, cavities occur as a result of local pressure drop on the spot.

Other damages resulting with part of fins ripped off or fin blades bended, are related with this damage. Those damages occurred when metal parts from cylinder No. 7 hit nozzle fins, enter into turbine and as a result of centrifugal force were blown back to the nozzle fins. Small parts but with great velocity (as turbine rotates with 20.000 rpm), result with big enough kinetic energy which could damage nozzle fins in such way.

Damaged turbine nozzle

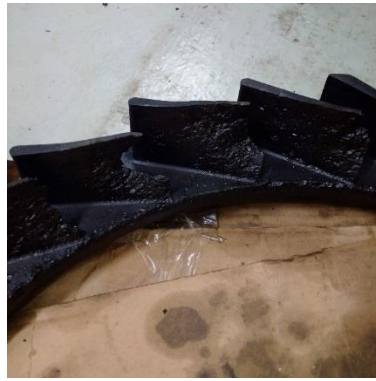
Damaged fins of the nozzle

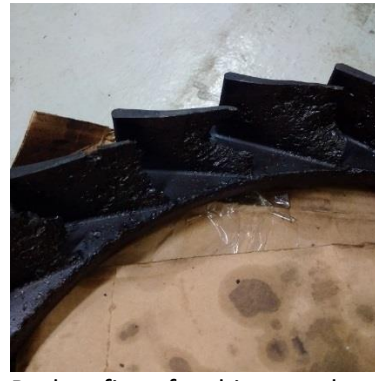
Broken fins of turbine nozzle

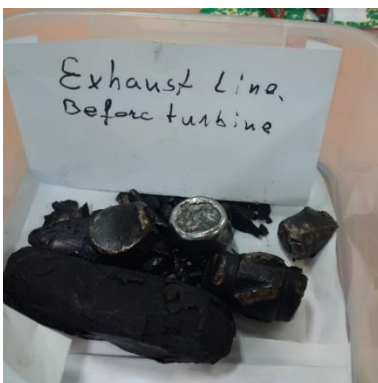
Broken parts from cylinder No.7 have been found through exhaust line manifold and inside turbine housing. Heavier parts didn't reach turbine, but lighter and smaller parts did reach turbine, causing earlier explained damage of turbine wheel and turbine nozzle fins.

Parts found in exhaust line, before turbine

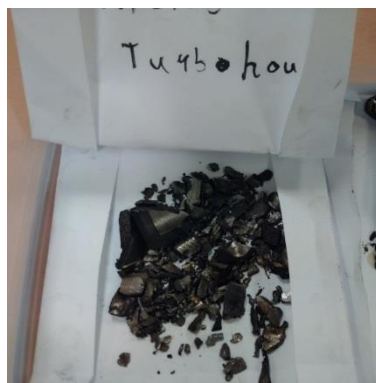
Parts found inside turbine housing

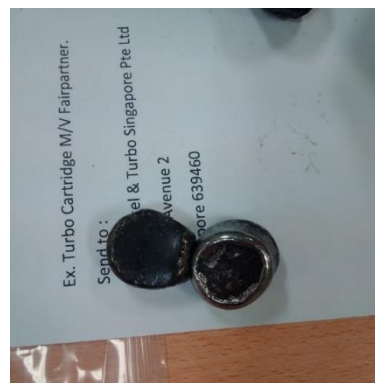
Broken parts from piston middle area

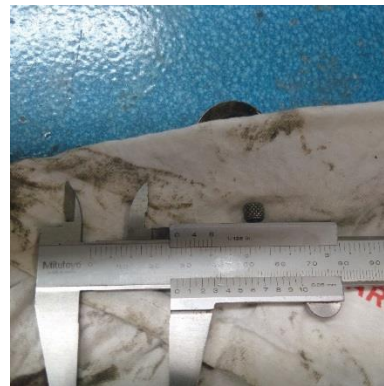
Having in view all damages, it might be concluded piston got in contact with only one moving part inside cylinder (except piston itself), valves. The question is: how piston can get in touch with valves? Normally piston movement is synchronized with valves opening and closing sequences, by camshaft. I have measured cam on camshaft, 27 mm. So, valve movement from close to open position is 27 mm. Then crew has put piston on TDC and have measured allowable distance for valve movement. It was measured also 27 mm. So, normally it is very difficult (if measurement was not 100% accurate) or impossible (if measurement was accurate) for piston to get in touch with open valves in any possible situation. Only with fully opened valve (what is extremely small possibility), piston could get in minor contact with a valve. Such impact from piston to valve (fully open), would be minor and could not lead to such kind of great damage. Piston would just push valve up, probably with no noticeable damage at the time. If valve would had been in partly opened position (what could be possible for a reason, like stuck or dirt) piston couldn't get in contact with partly opened valve. To conclude, it is highly unlikely, almost impossible, piston to reach any valve in movement.

Cam height 27 mm

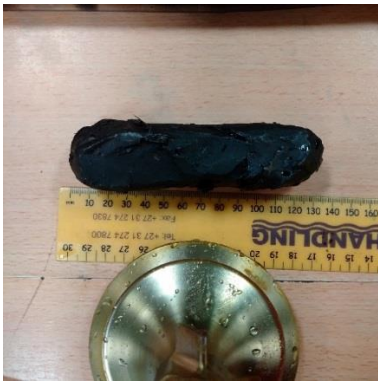
My point of view was this damage started with brake down of forward exhaust valve's crown. Once the crown was broken and detached from valve stem, it was moving randomly free inside cylinder No. 7. being hit from piston toward cylinder cover. Every time piston reached TDC, detached valve's crown had been pressed by piston to cylinder cover, performing actually forging of the detached crown. Piston was acting as a hammer and cylinder cover as anvil. As a result now it is square shape metal piece showed on Photos below. In support for described forging process description, sharp and hard free laminates are placed around below showed piece, which is typical and common for all forged pieces.

Bigger part of exhaust forward broken crown

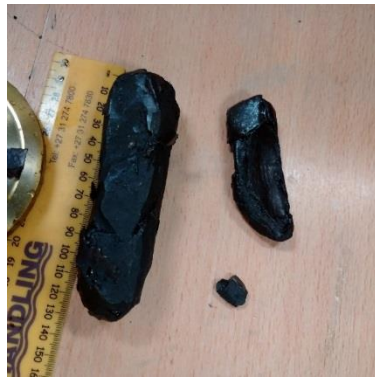
2 main parts of forged valve's crown

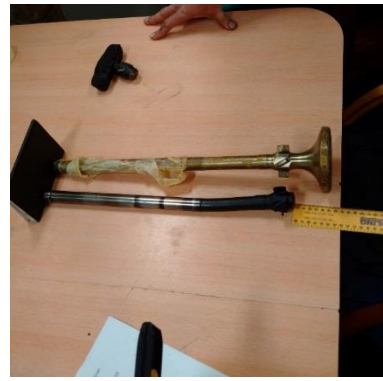
Comparison of damage exhaust forward valve with new one

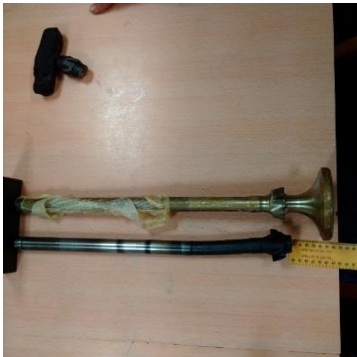
Almost the same volume of material is in missing parts of damaged exhaust forward valve and new exhaust gas valve as it is showed on photos below.

Damaged exhaust forward valve and new one

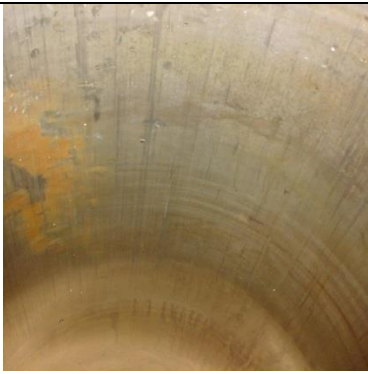
Scratches on cylinder liner

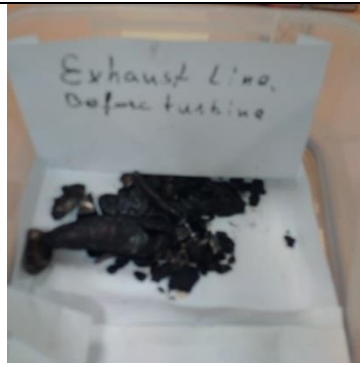
Detached pieces found in exhaust manifold

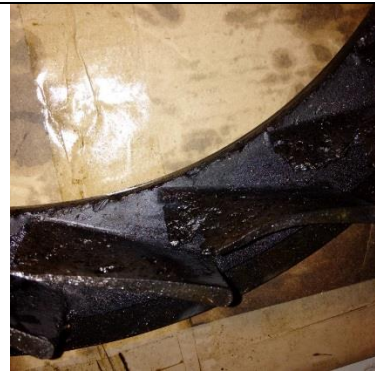
Damaged turbine nozzle

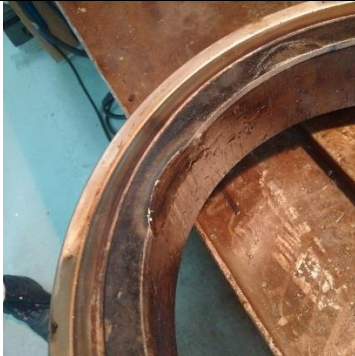
Damaged topland ring

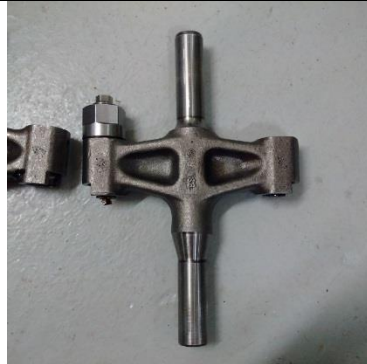
Bended spring pusher for inlet valves

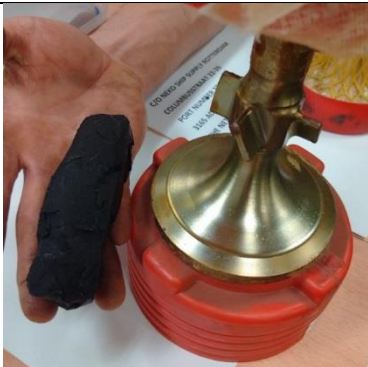
Valve's crown after forging

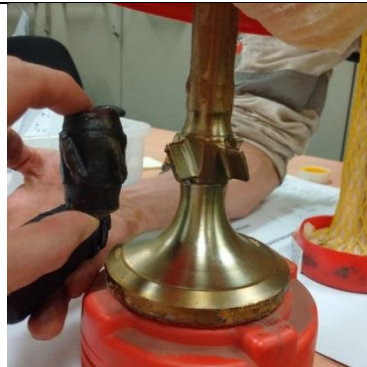
Detached fins piece from exhaust rear valve

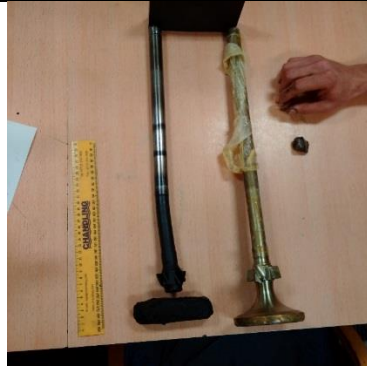
Damage exhaust fore and new valve

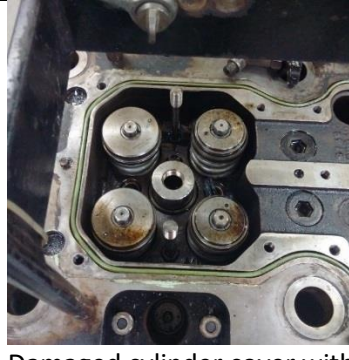
Damaged cylinder cover with stems in place

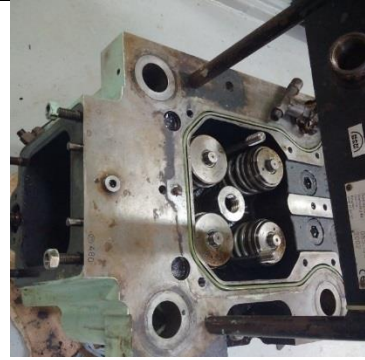
Damaged cylinder cover side view

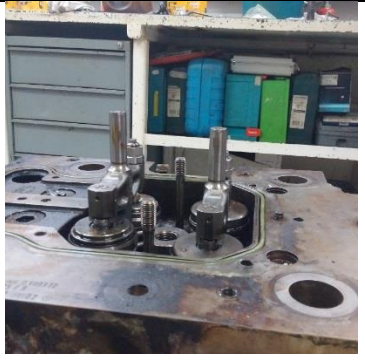
Damaged cylinder cover with spring pushers

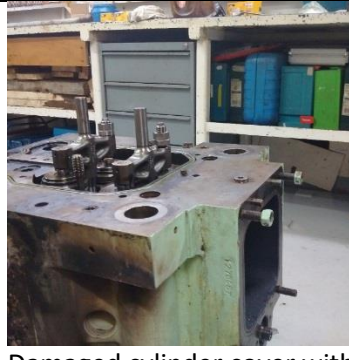
Damaged cylinder cover with pushers, side view
