Report of main engine damage on xxxxxxxxxxxxxxxxxxxx

Main Engine is MAN B&W, type 9L32/40, ser No. xxxxxxxx 750 rpm, 4320 kW, built 2002, on board newbuilt Ship from xxxx.

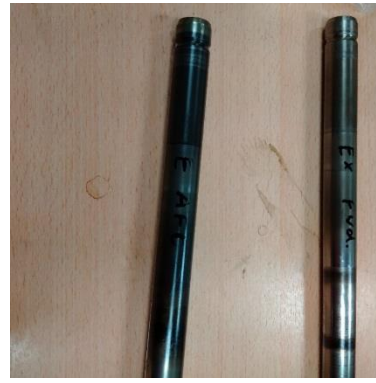
Exhaust forward valve has been found with valve crown missing, stem buckled, with fin part still on valve's stem.
 Exhaust rear valve has been found with valve crown broken, rotated for 90° from original stem vertical position and pressed in valve seat; also with stem buckled and fin part separated from the stem.
 Inlet forward valve has been found with broken valve crown, rotated for 90° from original stem vertical position and pressed in valve seat.
 Inlet rear valve has been found not broken, just with buckled stem and punched valve crown bottom.
 To conclude, only 1 valve (fresh air inlet rear valve, has been found with valve crown still connected with valve's stem.
 Other 3 valves have their crown detached from valve's stem.
 Valve opening pushers have been found slightly deformed (about 1,5 mm bended) on lower part (bigger diameter).

Exhaust gas valves description
