Report of main engine damage on xxxxxxxxxxxxxxxxxxxx

Main Engine is MAN B&W, type 9L32/40, ser No. xxxxxxxx 750 rpm, 4320 kW, built 2002, on board newbuilt Ship from xxxx.

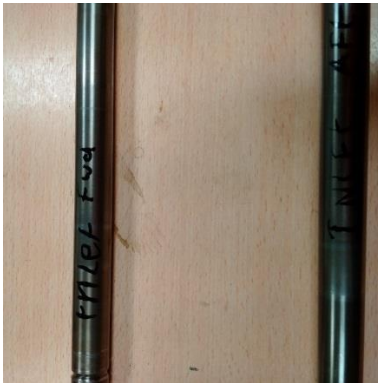
Exhaust forward valve has been found with valve crown missing, stem buckled, with fin part still on valve's stem.
 Exhaust rear valve has been found with valve crown broken, rotated for 90° from original stem vertical position and pressed in valve seat; also with stem buckled and fin part separated from the stem.
 Inlet forward valve has been found with broken valve crown, rotated for 90° from original stem vertical position and pressed in valve seat.
 Inlet rear valve has been found not broken, just with buckled stem and punched valve crown bottom.
 To conclude, only 1 valve (fresh air inlet rear valve, has been found with valve crown still connected with valve's stem.
 Other 3 valves have their crown detached from valve's stem.
 Valve opening pushers have been found slightly deformed (about 1,5 mm bended) on lower part (bigger diameter).

Valve air inlet description

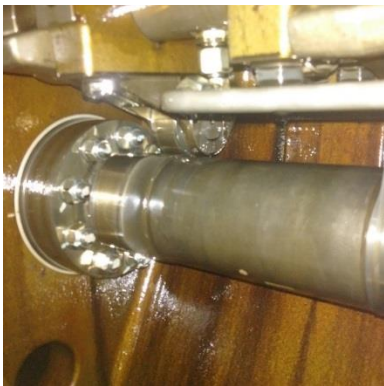
Camshaft

Having in view all damages, it might be concluded piston got in contact with only one moving part inside cylinder (except piston itself), valves. The question is: how piston can get in touch with valves? Normally piston movement is synchronized with valves opening and closing sequences, by camshaft. I have measured cam on camshaft, 27 mm. So, valve movement from close to open position is 27 mm. Then crew has put piston on TDC and have measured allowable distance for valve movement. It was measured also 27 mm. So, normally it is very difficult (if measurement was not 100% accurate) or impossible (if measurement was accurate) for piston to get in touch with open valves in any possible situation. Only with fully opened valve (what is extremely small possibility), piston could get in minor contact with a valve. Such impact from piston to valve (fully open), would be minor and could not lead to such kind of great damage. Piston would just push valve up, probably with no noticeable damage at the time. If valve would had been in partly opened position (what could be possible for a reason, like stuck or dirt) piston couldn't get in contact with partly opened valve. To conclude, it is highly unlikely, almost impossible, piston to reach any valve in movement.

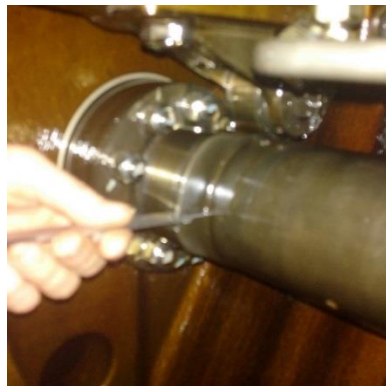
Measuring cam height

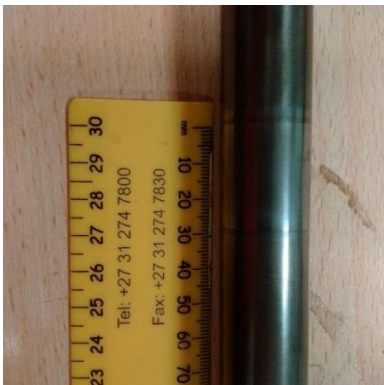
27 mm path marks

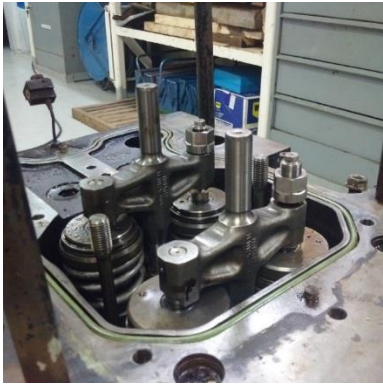
Valve opening arrangement

From MAN technicians (as per crew explanation), idea was forced that problem was in wrongly adjusted clearance between valve top and pusher. It was recorded upon valve casing opening, adjustment Nut on both valves was found loose. Loose Nut could not create precondition for this damage. It could make only shorter valve movement path, having for consequence to eliminate any possibility for piston-valve contact due to movement path shorter than 27 mm, depending how much greater clearance was.

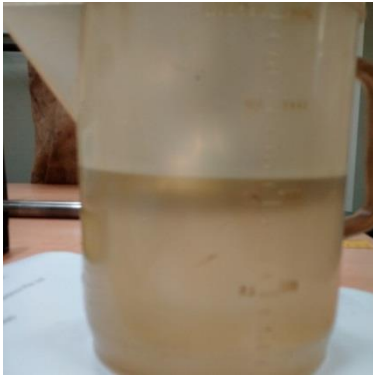
In order to support assertion that big forged piece is actually detached exhaust forward valve's crown, I measured volume of forged piece comparing with volume of original new exhaust gas valve crown. A pot with proportion scale was taken, filled with 1000 ml water. List was checked and it was 0. Forged piece was placed in the pot, giving new reading of 1100 ml of water. So, volume of big forged piece was 100 ml or 0,78 kg of weight. After, new exhaust gas valve was placed in the same pot until reading reached 1100 ml. It had to be submerged down to the position showed on the Photo in table below (around 55 mm from valve's bottom). It is to conclude, big metal piece together with another smaller piece (showed in Photo in "my point of view" section) and other much smaller pieces, undoubtedly show they are from detached exhaust forward valve's crown. Having it proved, before described damaging process is right one, in all aspects.

Pot with proportion scale

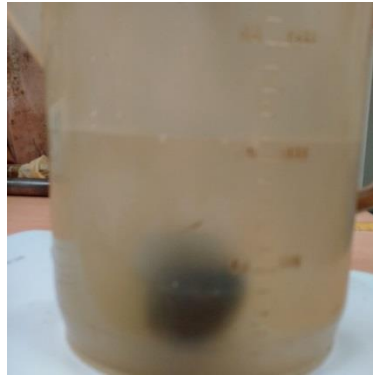
Forged piece volume measurement

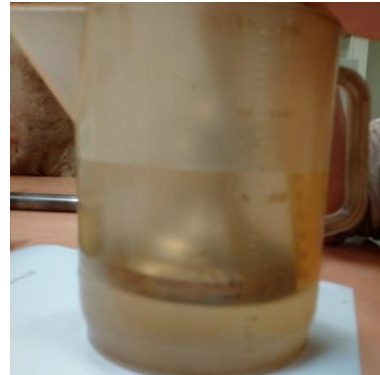
New valve volume measurement

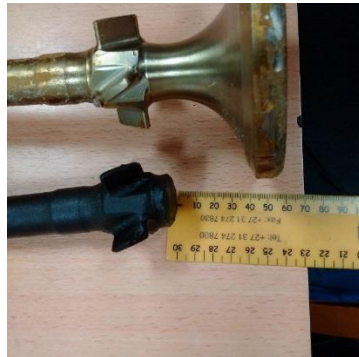
Almost the same volume of material is in missing parts of damaged exhaust forward valve and new exhaust gas valve as it is showed on photos below.

Closer view

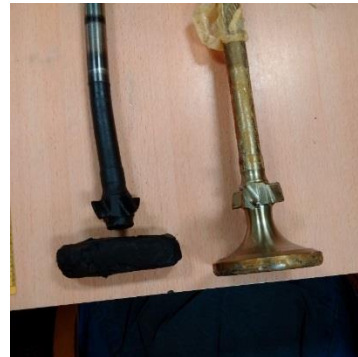
Restoration with compare

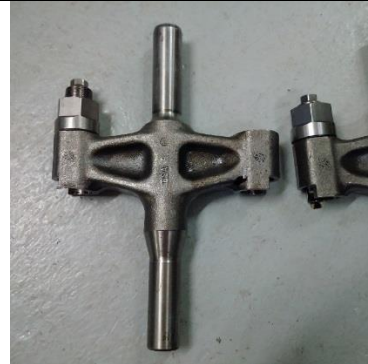
Bended spring pusher for exhaust valves

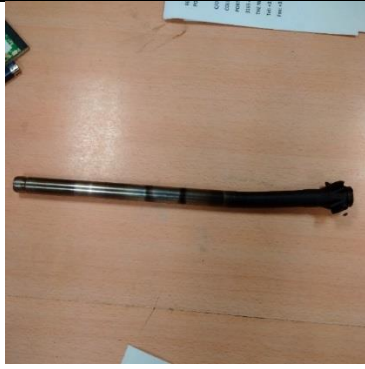
Exhaust fore valve's stem
